3.3A VISUAL ANALYSIS - STAGE D AREA

3.3B VISUAL ANALYSIS - STAGE C AREA

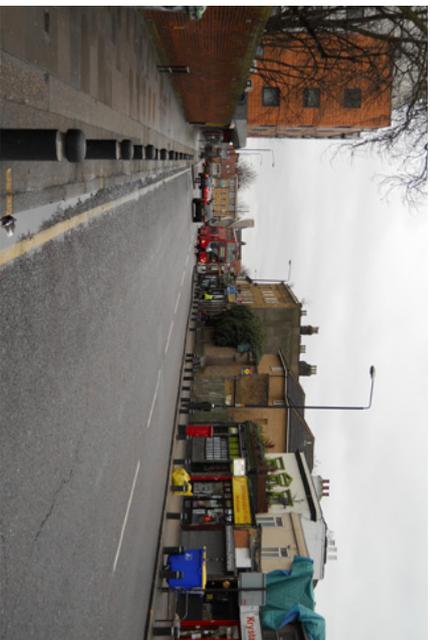
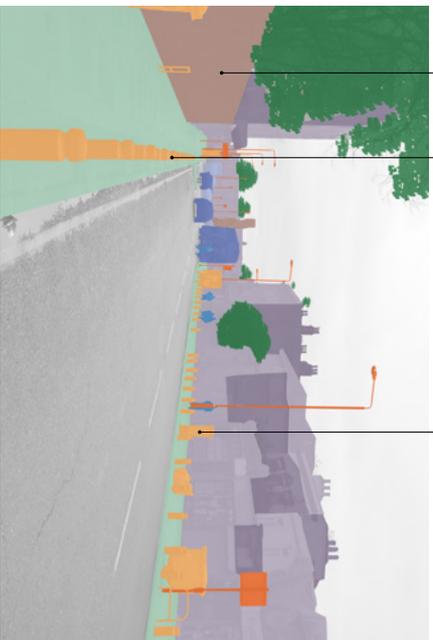
5. Leytonstone Road (north) looking south

Potential for enhancement of wall (future stage - consider participation of school)

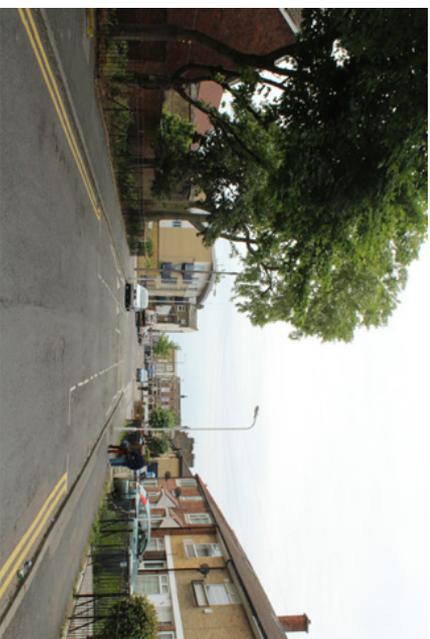
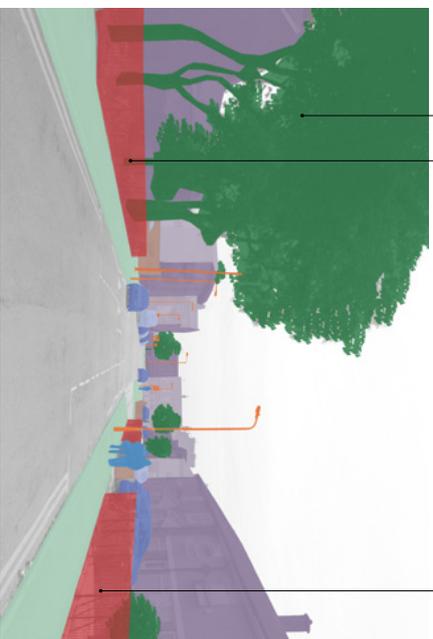
6. Well Street looking south

Incongruous street furniture and excessive number of bollards create a dispersed public realm

Opportunity to create new public open space by incorporating existing mature planting

Consider removal of railings to create a pleasant pedestrian environment

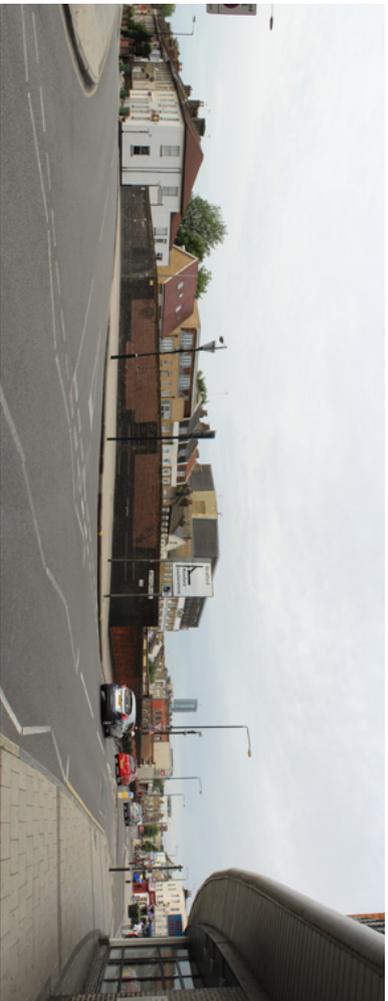
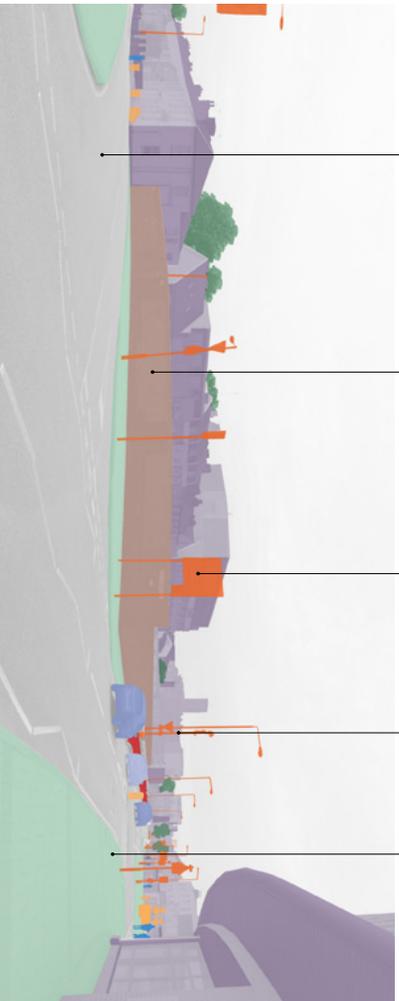
8. Forest Lane - Water Lane junction looking west

Movement of vehicles adversely affects pedestrian and cycle access

Incongruous street furniture creates clutter in the public realm

Highly constricted pedestrian access at key junctions

Consider improvement of cladding material or potential for public art

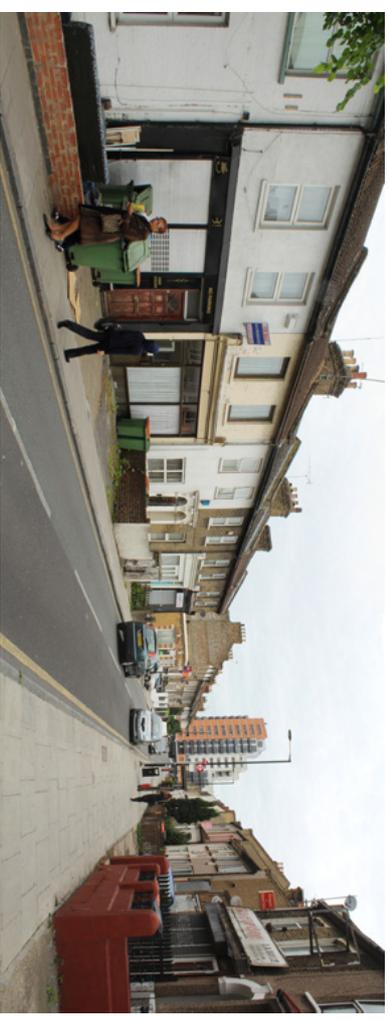
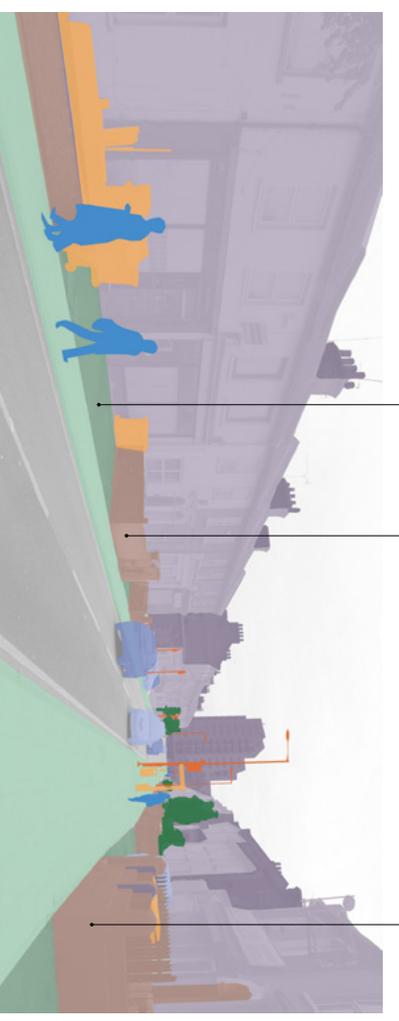
9. Water Lane looking north

Poor quality surface treatment of residential forecourts / pedestrian access

Lack of consistent language of external structures and materials

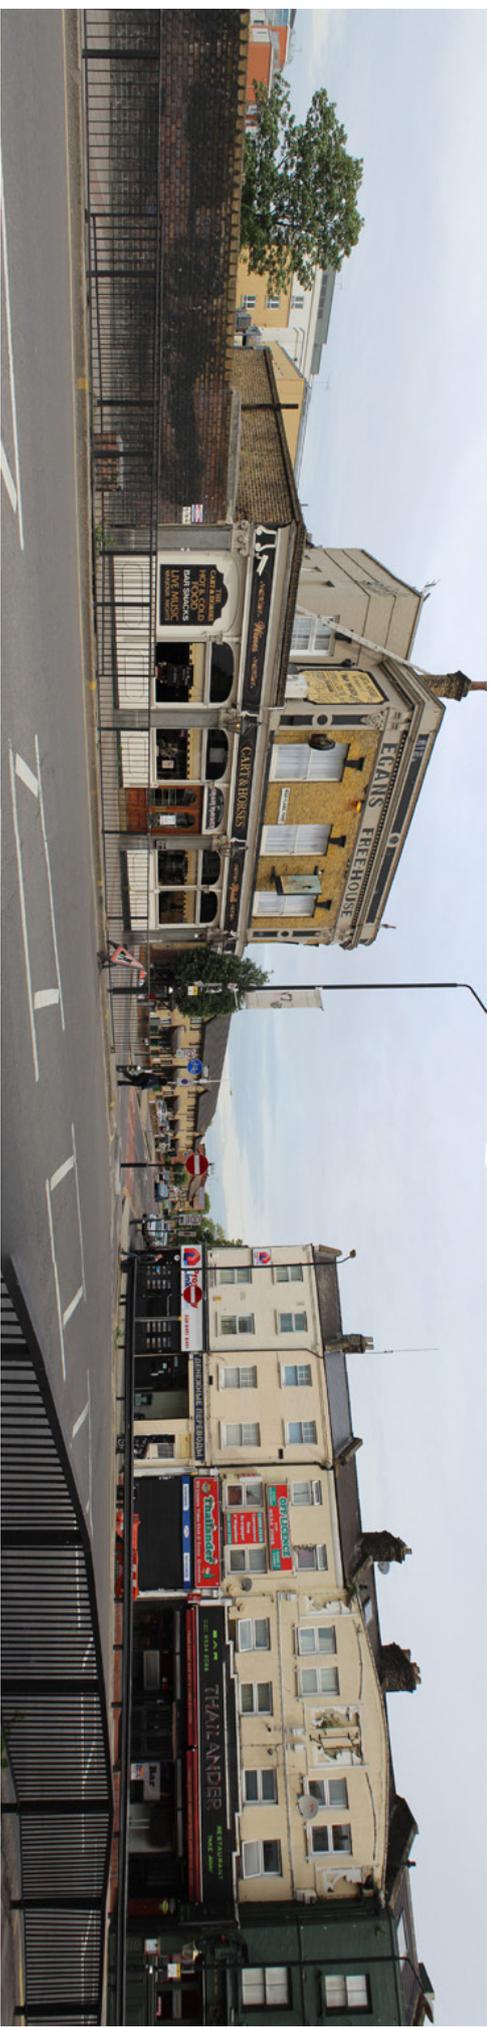
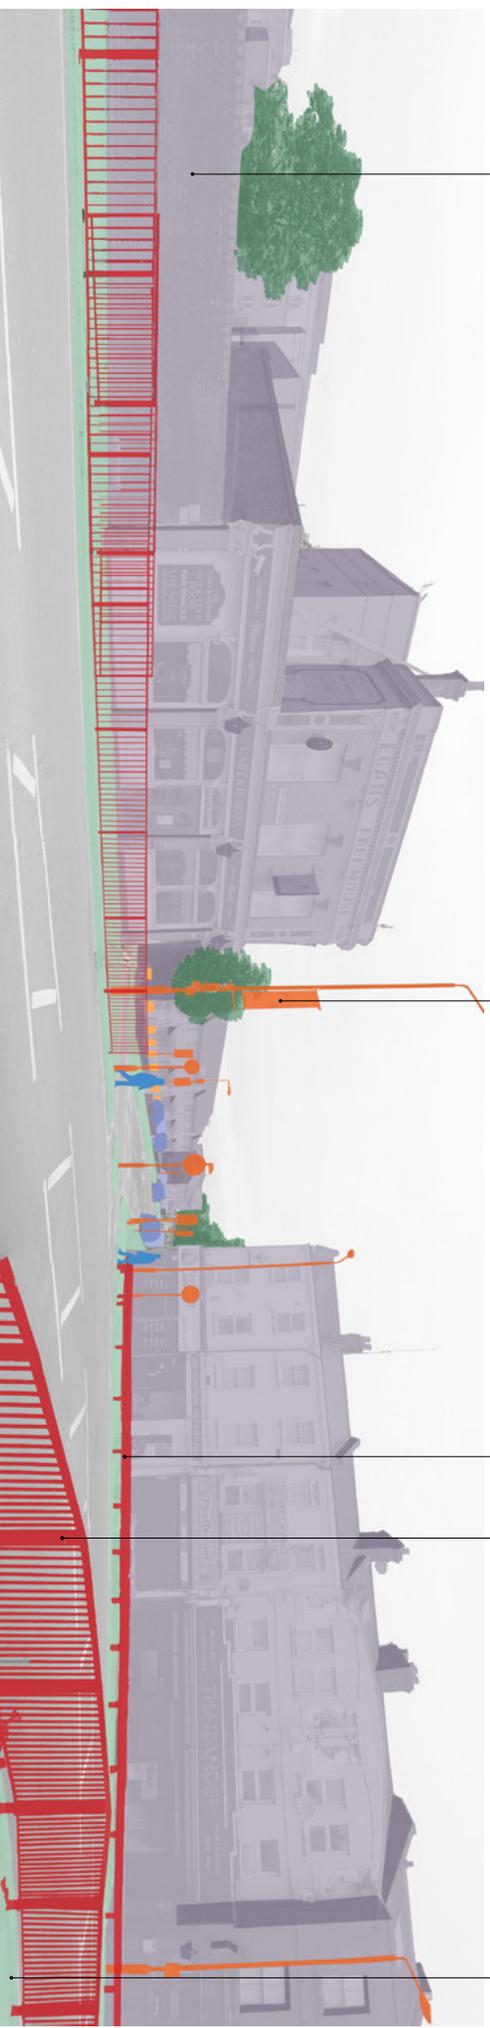
10. Maryland Point - panorama looking towards Well Street - Windmill Lane Junction

Incongruous street furniture creates clutter

An excessive amount of railings and crash barriers create clutter and hostile pedestrian environment

Highly constricted pedestrian access on approach to Maryland Station

Potential for enhancement of wall
