**Roadworks Patrol – 4<sup>th</sup> June 2018**

**Roadworks Patrol Introduction**

**Zone 1 (westbound) Broadway**

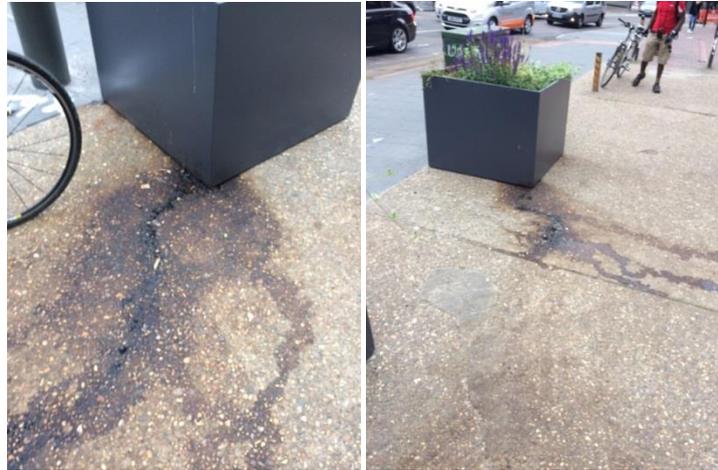
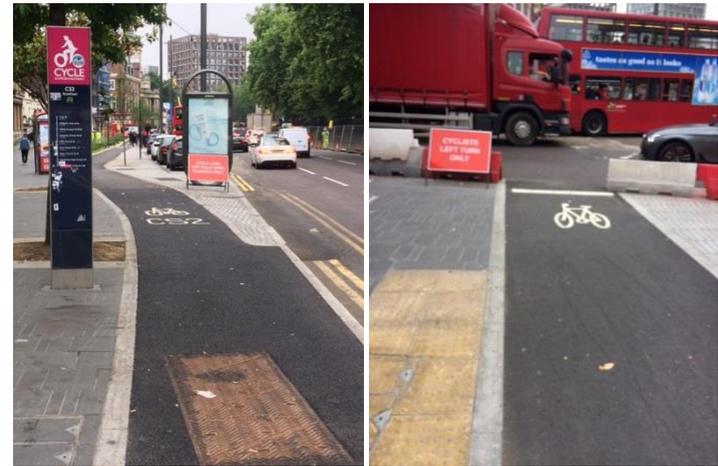
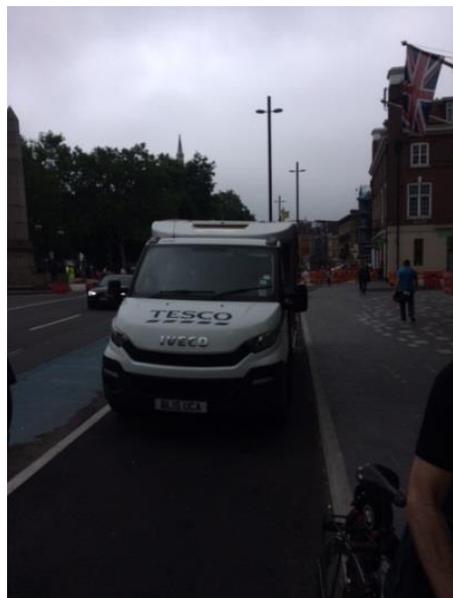
**Unsavoury leakage from planters**

**Advance warning sign 'cycle lane not fully completed' to far from start of track.**

**Cyclists turn left only sign is warning only. Concerns that cyclists missing 'cycle lane not completed' signs may risk straight ahead movement.**

**MB discussed issue with driver of Tesco lorry. Reply was 'confused with layout'**

**PG requested photo to be forward immediately**

**Suggest relocate at the entrance to warn cyclists**

**Sign to be relocated to start of the cycle lane.**

**Investigate use prohibitory sign for left only**

**Left turn only sign relocated in advance of stop line, with left turn only sign added.**

**Suggest monitoring once works are completed and to re-investigate signage options for the new loading area if not clearly visible to drivers.**

**Agree**

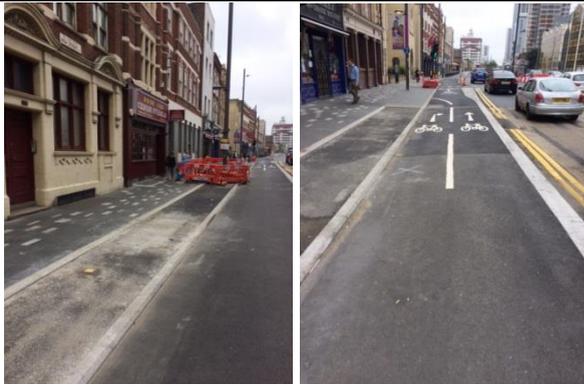
Very narrow walkway and some traffic management protruding onto the track

Confusion with arrow markings as there is no dropped kerb to allow access on the footway.

**Can this be tweaked to remove obstruction and widen for pedestrians?**

Agree

**Update on scheme for kerb works required**

Pedestrian barriers will be altered to widen the pedestrian route.

Temporary bitumeun will form a ramp in the short term until work is complete. Sign to be added for direction route to Great Eastern Road.

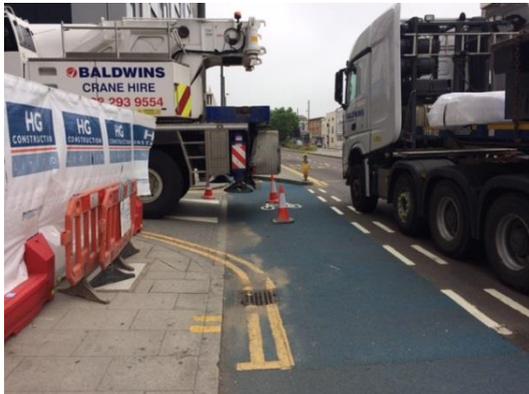
HGVs observed blocking the footway and cycle track with no marshals to guide vulnerable road users

**Relay to Planning team as a safety concern requiring immediate mitigation.**

Forwarded on to LBN highways management team.

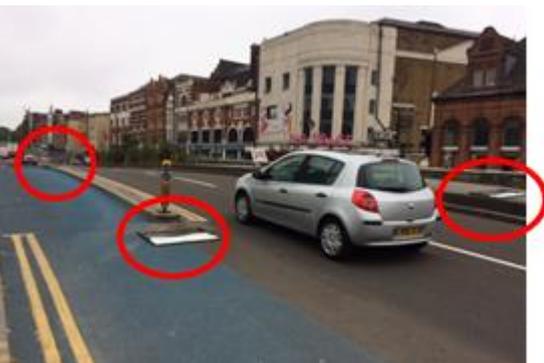
4 x signs with two causing a partial obstruction in the cycle track

**Removal needed if not required**

Agree

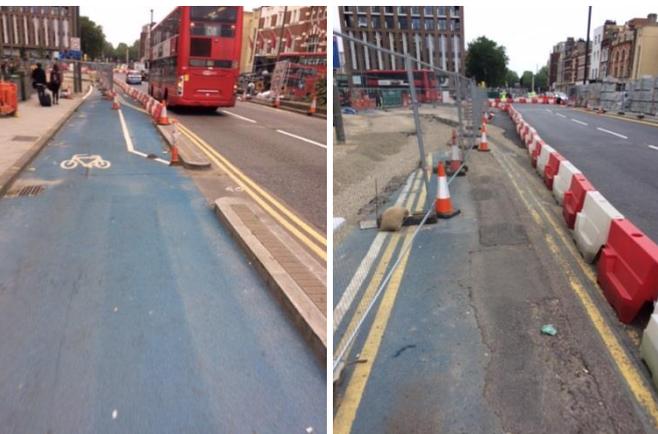
Obstructions in track - an 'orca' segregator and cylinder base

Water filled barriers and heras fencing has narrowing sections

**Both require removal**

Agree

**Investigate whether extra space can be gained via relocation**

Hares fence adjusted to widen track.

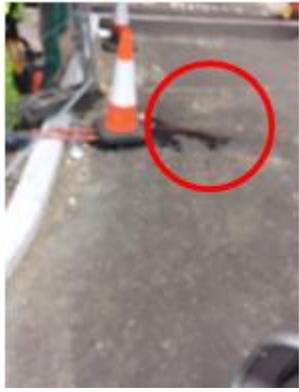
Wires protruding from surface causing a trip hazard

Chase into surface and overlay with asphalt

Resolved

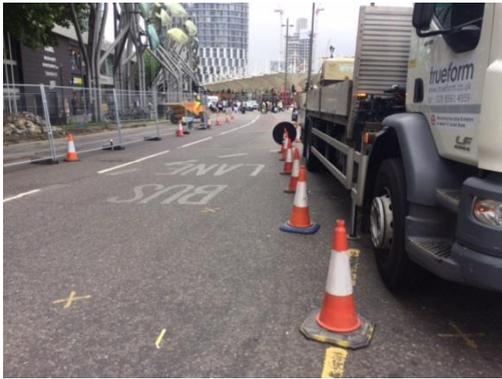
Truform (bus shelter removal) traffic management(TM) causing a nasty pinch point not helped by too close to site road narrows sign location.

MB discussed with site team to relocate road narrow sign supplying better advance notice

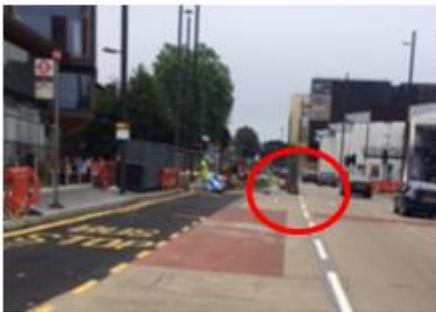
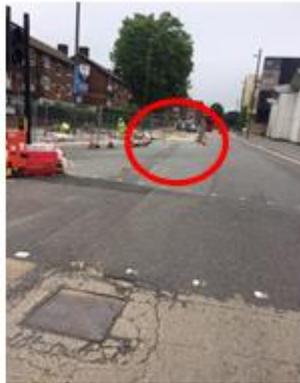
Two sections of works missing visual TM and keep right arrows

Suggestions to implement additions

Additions have been added, and operatives have been advised of failure

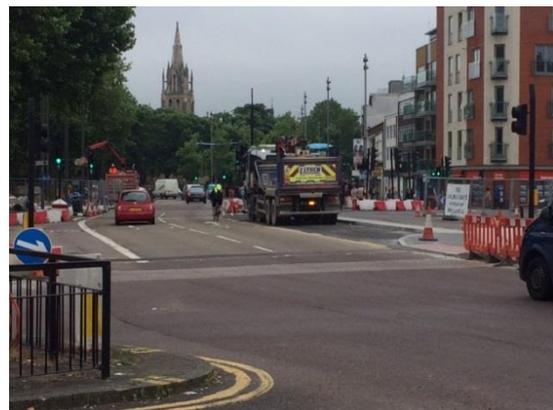
Lynch lorry waiting in front of push button pole at crossing, visibility obstruction of pedestrians waiting to cross

Inform all supply chain not to wait in that location or where there may be visibility obstructions

TM has been put in place to close this lane until new Signals are in operation.

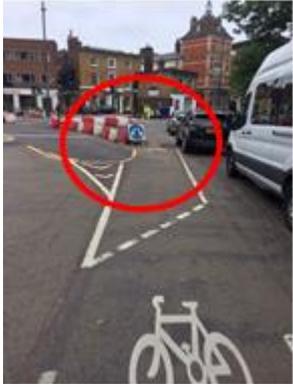
**Directional arrow location causing obstruction**

**Relocate to supply improved passing width for cyclists**

Agree, sign and water filled barriers to be altered to improve things for all using the junction.
